Fabrication and Evaluation of Welded Ti-6Al-4V Test Sections

ARL-TR-2533

June 2001

Army Research Laboratory

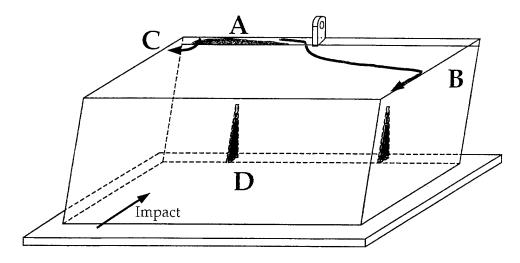
Figure 7. ARL overview, schematic 1.

but was still considered a penetration. The third and final round was a shock round to test the weld toughness, the result of which was considerable cracking. The ARL section had its primary fracture from this round at the top back left hand side (LHS) of the box, point A in Figure 7. Inspection revealed that the inside surface of the top plate in that area had taken an impact load from the armor package during the ballistic event (See GDLS Test Section Ballistic Results). Consequently, the top plate to back plate joint failed from overpressure down a 23-in span, point A, along the weld. The top 1/4-1/2 in of this weld zone failed in shear. Beyond this region, cracking advanced out of the weld joint and proceeded into the base material of the top plate, most likely as a result of the lifting hook being welded across the plate interface in this area (see schematic). Cracking progressed through the top plate, until the right hand side (RHS) of the top to side plate joint was reached at the approximate halfway point (Figure 7, point B). The crack then turned and followed the top to side plate joint approximately 6 in before arresting. The other end of the crack, emanating from the primary fracture, met (at the top back LHS corner, point C) with a crack from a secondary fracture that initiated at the base of the LHS gusset support (Figures 7 and 8, point D). In all likelihood, cracking originated from this area due to the fact that several weld beads converge here. This area was almost directly behind the point of collision of the round as it impacted the back plate (or impacted the armor package that, in turn, impacted the back plate). Failure most likely occurred here because the weld beads were discontinuous in this area.

The primary fracture occurred as a result of overpressure. This indicates that the weld was not tough (a measure of both strength and ductility) enough to stop cracking from initiating. Preventing crack initiation can eliminate crack progression. The results of the other welds on both the ARL and GDLS test section (in the case of the back plate to bottom plate interface discussed previously) indicate a nearly functional weld process. However, the stresses on the top plate to back plate interface still need to be lowered. In the opinion of ARL, the top plate should be increased in thickness to approximately 1.5 in to allow for a larger weld area to reduce the stress at this interface. It should be noted that the RHA box also had significant cracking (10–15 in) in this area.

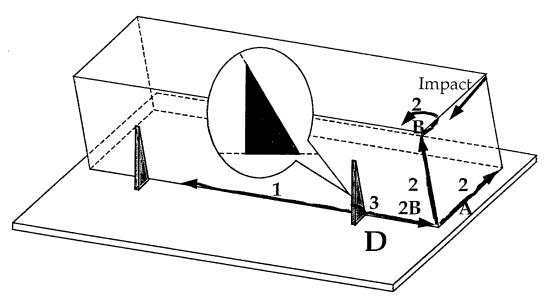
Figure 8. ARL overview, schematic 2.

The secondary fracture, crack no. 1 in Figure 8, ran along the back to bottom plate interface and continued approximately 30 in until it arrested. Crack no. 2 proceeded to the LHS (from front orientation) bottom back corner and wrapped

around the edge of the box. It then split in two, cracks 2A and 2B. Crack 2A proceeded along the LHS to the bottom weld interface approximately 15 in where it arrested. Crack 2B ran along the LHS back to the side weld interface and curled around the top of the plate where it met with the crack from the primary fracture and arrested. Crack no. 3 proceeded directly into the base material of the LHS gusset and ran entirely through the support; Figure 8 shows the details.

The secondary fracture most likely occurred from a combination of a lack of weld material along the back to base plate interface and the stop/start point of six weld root passes being in the corner of the gusset. A redesign of the welding in this area would result in the entire back plate to base plate interface being welded before the addition of the gusset supports. The fact that the GDLS test section had more weld metal in this area, a very similar weld design, continuous weld beads, and minimal cracking in this area substantiates this (See GDLS Test Section Ballistic Results). The main point here is that ARL believes the cracking originated from a fault in the welding procedure (discontinuous weld beads), not from a fault in the weld design.

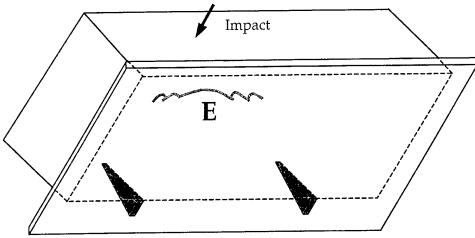
Figure 9. ARL overview, schematic 3.

Tertiary fracture occurred entirely within the base plate material from the entry of the shock round in the front plate. The 1-in-thick base plate failed along a 14-in section due to the bending moment and stresses from the impacting projectile. This can be observed in Figure 9, point E, and in Figure 10. This crack can most likely be eliminated from a simple redesign of the front to base plate weld and would not occur on a vehicle due to the joint design differences.

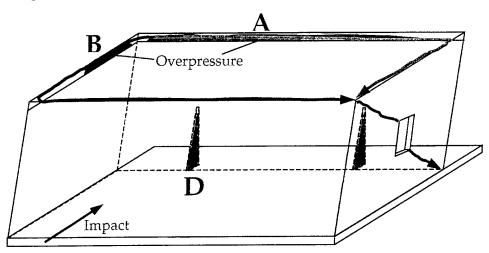
Figure 12. GDLS overview, schematic 1.

The GDLS test section had its primary fracture originate at the top back LHS of the box, point A in Figure 12.

It was apparent that the inside surface of the top plate in that area had taken an impact load from the armor package. There were linear deformation marks on the inside surface of the top plate that matched the configuration of the armor package. Additionally, the GDLS box weld interface did not match the proposed design of the region, as observed in the picture of the weld failure (see Figures 13 and 14). The top to back plate interface was designed as shown in Figure 13, however; the test section also had an extra step shown.

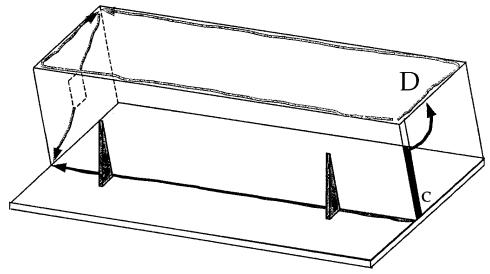
Figure 15. GDLS overview, schematic 2.

The secondary fracture occurred along the inside back to LHS side plate and back to base plate interfaces. The back to side plate failure originated from overpressure along a 17-in section toward the bottom of that interface (see Figure 15, point C). Cracks progressed along the back to bottom plate weld interface. From the other end of the overpressure zone, cracking advanced into the base material of the LHS side plate until it met the crack path of the top plate from the primary failure (see Figure 15, point D).

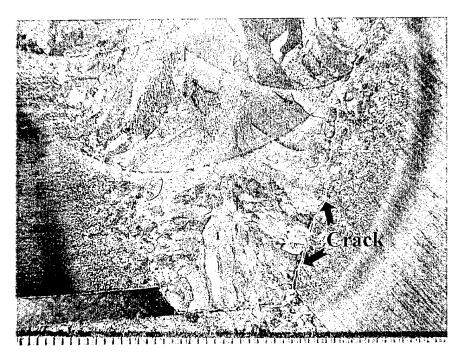
Figure 19. Cross section showing a fine crack in the front plate to top plate weldment.

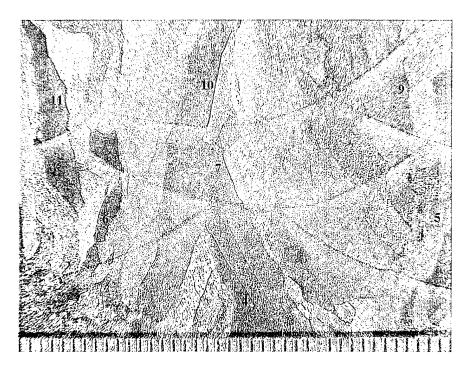
Figure 20. Front to top plate fusion zone with grain growth across weld pass boundaries.

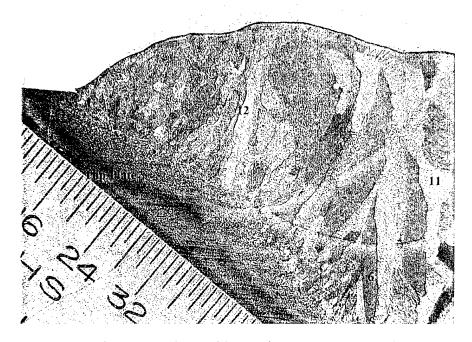
Figure 21. Front plate to top plate weldment showing approximately 1/8-in HAZ.
